Case History

Comparing a new technology with a proven one

Instrument: PyxisGC BTEX

Costumer: ARPA Puglia

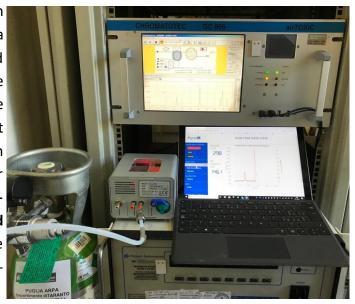
The PyxisGC BTEX installation operations in the cabin were carried out by ARPA Puglia specialized technicians, with pre-calibrated instrumentats. In order to evaluate the PyxisGC BTEX instrumental performance, the test was structured following two steps. First of all, the parallel measurement of gas from a pre-and post-monitoring certified cylinder was carried out. Finally, monitoring was carried out in parallel with PyxisGC BTEX and GC 866 Chromatotec, both installed inside the ARPA Puglia air quality cabin, over a period of 7 weeks.

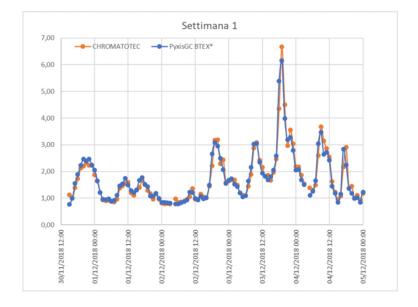
In the light of the results obtained, we can say that the Pyxis GC BTEX follows perfectly the trend of the measurements detected with the ARPA Puglia control unit, even though it hadn't been calibrated during the entire test period, thus demonstrating **the instrument high reliability and the accuracy of the measurements.**
